COMBATTING CLIMATE CHANGE WITH SUSTAINABLE MEASURES: A CASE STUDY OF MOUSUNI ISLAND, INDIAN SUNDARBANS

The objective of the study is to assess the suitability of embankments to combat coastal inundation as an effect of sea level rise and/or tropical cyclones which are enhanced by the ongoing climate change in the island.

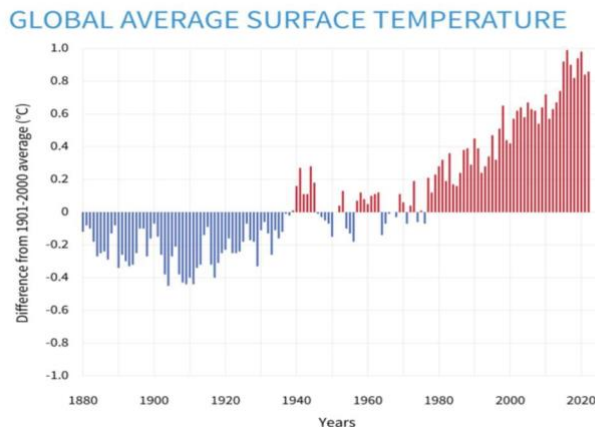
Fig. 1: Yearly surface temperature compared to the 20th century average from 1880-2022.

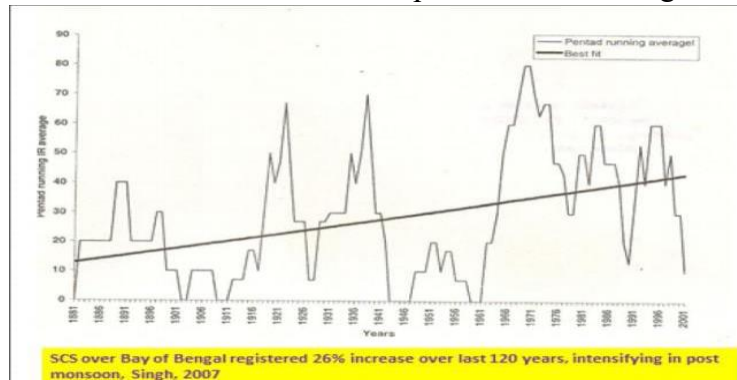
Fig.3: Raise of frequency of severe cyclonic storms over Bay of Bengal
Source: Singh, 2007

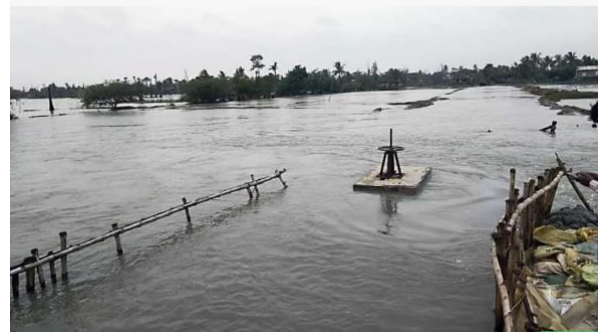
Fig.4: An inundated stretch of Mousuni island on the western end of the Sundarbans
Source: modified by Jayanta das, *Telegraph*, 6th dec., 2021

Due to lack of monetary support, the residents cannot rebuild the resources with proper infrastructure. Cyclone Jawad, despite losing steam, was still strong enough to trigger a collapse in an embankment at Mousuni island, sandwiched between Gangasagar and Bakkhali, on the western fringes of the Sundarbans, marooning thousands. (Source: *The telegraph*, 6th December, 2021)

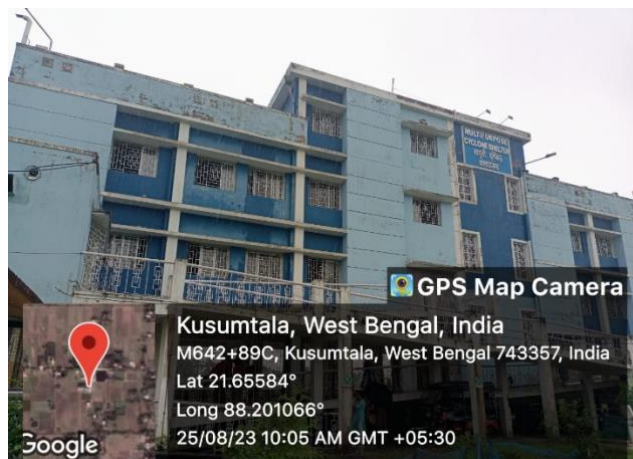
Fig.5: Multipurpose cyclone shelter at Kusumtala
Source: Captured by author, 25th August, 2023

Based on the primary survey, cyclone shelters of this island were also surveyed. A total number of four cyclone shelters are there (according to locals), but only 3 could be surveyed. The multipurpose cyclone shelter is the largest among the three and well-structured with three floors and around 18 rooms in all near Kusumtala. Each and every cyclone shelter is provided with tube wells whereas the electrical system is fully destroyed in spite of having well electrical connections. All cyclone shelters are not accessible by the locals of Mousuni due to its location. The one living near the shelters can access it well while the others cannot during the extreme climatic condition. Cyclone shelter cannot alone combat the vulnerability without people's contribution to adapt strategic policies and mitigation measures. The embankments made for combatting the vulnerability are too weak to protect the island from this monsoonal rainfall. Thus, the tremendous effect of cyclone raises the levels of the sea which continuously erodes them more.

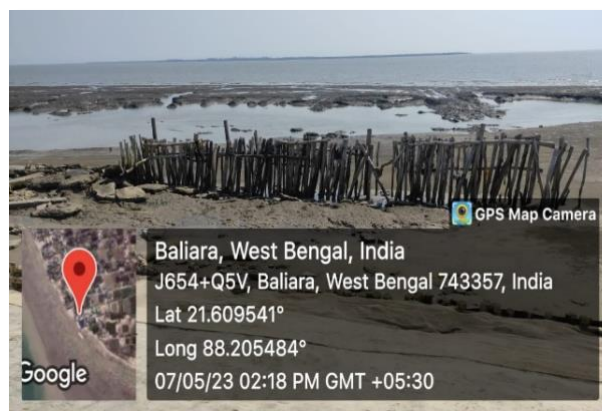
Fig.6: Wooden log embankment
Source: Picture captured by author. Date: 7th May 2023

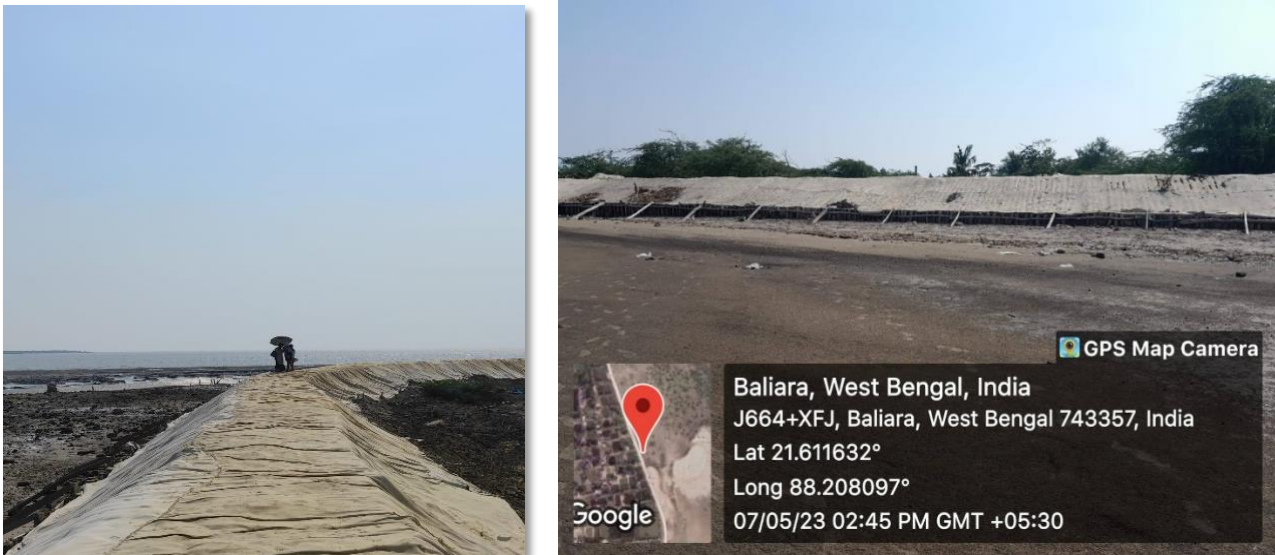
Fig.7: Earthen embankments covered with Geojute.

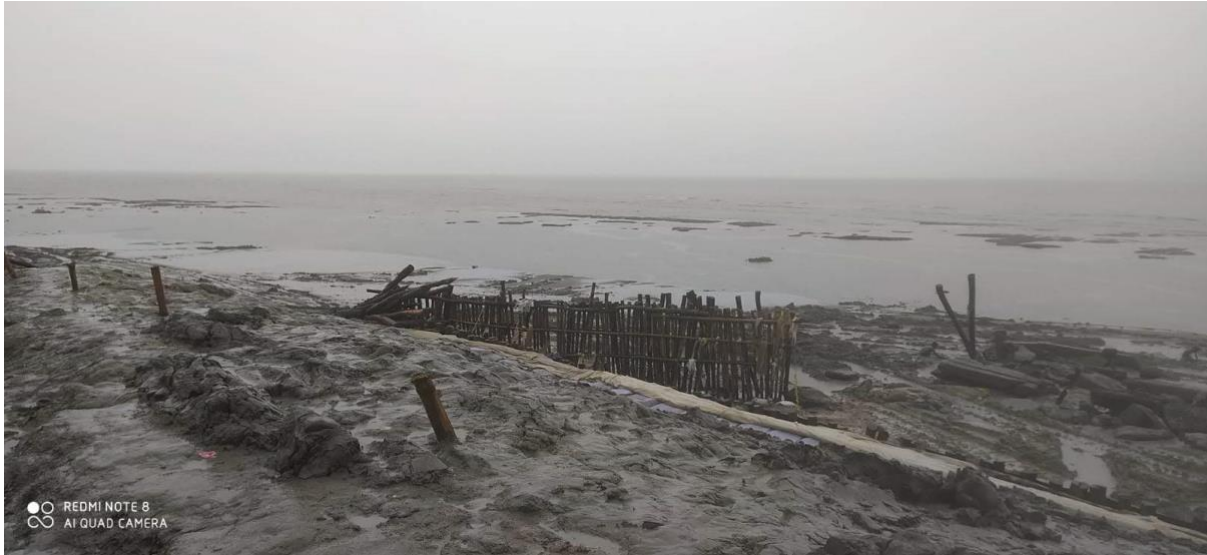
Fig.8: Demolition of earthen embankments which was covered with Geojute in Mousuni island, Baliara block.
Source: Captured by author, 25th august,2023

Intrusion of salt water due to flooding during environment hazards like cyclone which has vastly affected the inhabitants. Coastal erosion by tidal wave is observed in the surveyed area resulting in degrading quality of embankment. Failure of embankment results in quality degradation of agricultural land due to salt water intrusion in the affected areas.

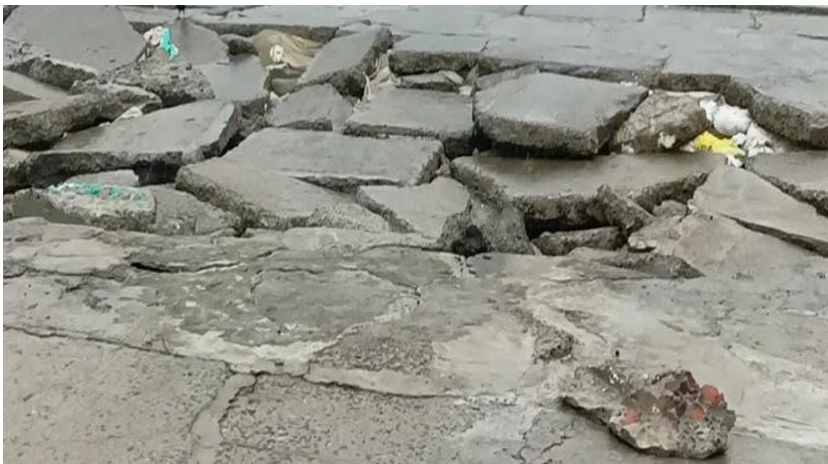
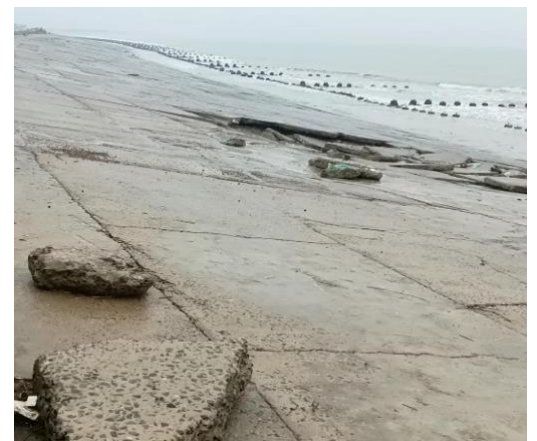
Through primary field visits the present condition of Aila embankments seems to be not effective. Slab failure and collapse due to improper base construction, structural failure and lack of technology is noticeable. Along with the concrete embankment, Groin structures are also observed. It is a structure extending from the shore into the sea. The main function of a Groyne is catching and trapping part of the sediment moving mainly in a longshore direction (when placed vertically) in the surf zone. As revealed by experiments, groynes partly dissipate energy of water motion (when horizontally placed) during weak and moderate wave conditions, leading to accretion of the updrift shoreline. Both vertical and horizontal

Fig.9: Slab collapse due to faulty construction of the concrete embankment in Mousuni island, Kusumtala block.
Source: Photographed by author. Date:25th August,2023.

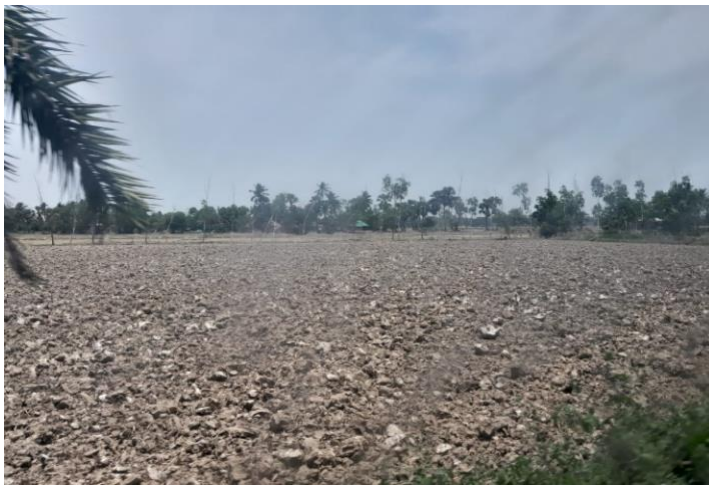
Fig.10: Salt pan formed due to saline water intrusion in Mousuni Island.

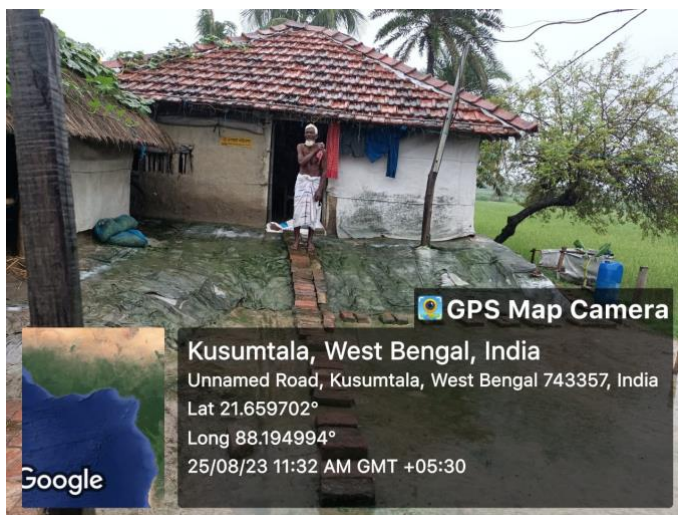
Fig.12: A house of a local protected by using sustainable measures
 Source: Picture captured by author, 25th August, 2023

One of the locals has adopted sustainable measures by lifting his house using certain local materials to combat cyclonic effects and flood. Their main need is a proper embankment around the riverine area and the coastal areas. In fact, most of them are willing to leave the place with help from government. Though some of them are staying as fisherman and are happy to live their livelihood. Most of the youth have migrated to some other places like Kerala in search of job. Schools were also seen near Bagdanga ghat with more
